CULTURAL LANDSCAPE REPORT
FOR THE SANDY HOOK
COASTAL DEFENSE BATTERIES
GATEWAY NATIONAL RECREATION AREA

CULTURAL LANDSCAPE REPORT FOR THE SANDY HOOK COASTAL DEFENSE BATTERIES

GATEWAY NATIONAL RECREATION AREA

FORT HANCOCK, NEW JERSEY

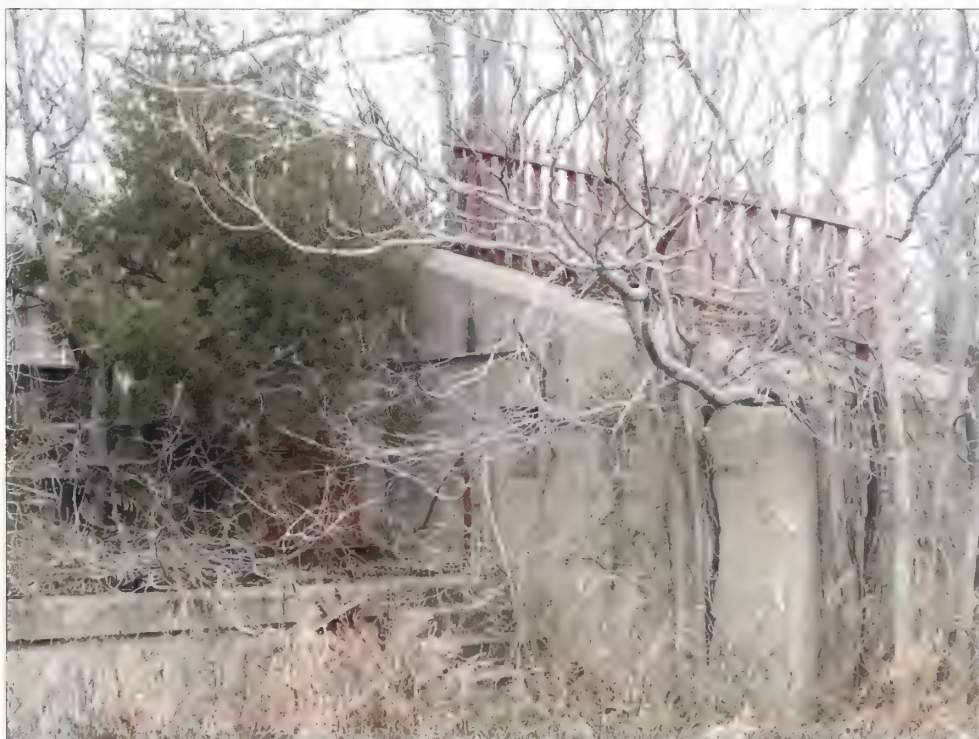
Figure 5.34. Wood picket fence on top of Battery Morris. The entire length of the pictured non-historic fence should be removed. Great care should be exercised not to damage the historic concrete structures and the historic earthwork north of the battery when the posts are removed (Olmsted Center, January 2009).

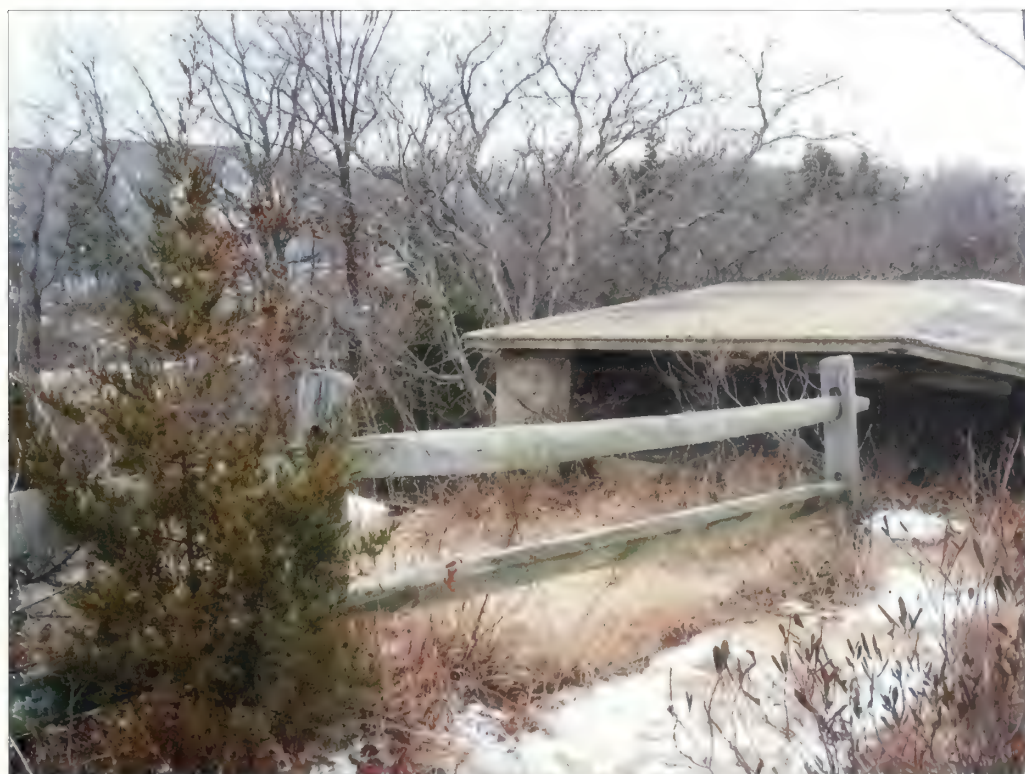
East of Battery Engle, a social trail winds up an engineered slope and connects to a series of trails around Battery Peck that lead to the observation platform. Although a spilt-rail fence has been installed, users have worn a path that squeezes between the fence and the historic structure (see Figure 5.36). In order to protect the historic engineered earthwork and limit potential erosion, the social trail should be closed. Low-growing native shrubs should be planted at the top and bottom of the trail to block access. Additional information on appropriate species and installing erosion control materials is presented in the treatment tasks common to all battery sites section.

Figure 5.36. View looking northwest at Battery Engle (CRF Station Peck). Although a split-rail fence has been installed as a safety measure, park visitors have trod a path that squeezes between the fence and the historic structure. Low-growing native shrubs should be planted at the top and bottom of the trail to block access (Olmsted Center, January 2009).

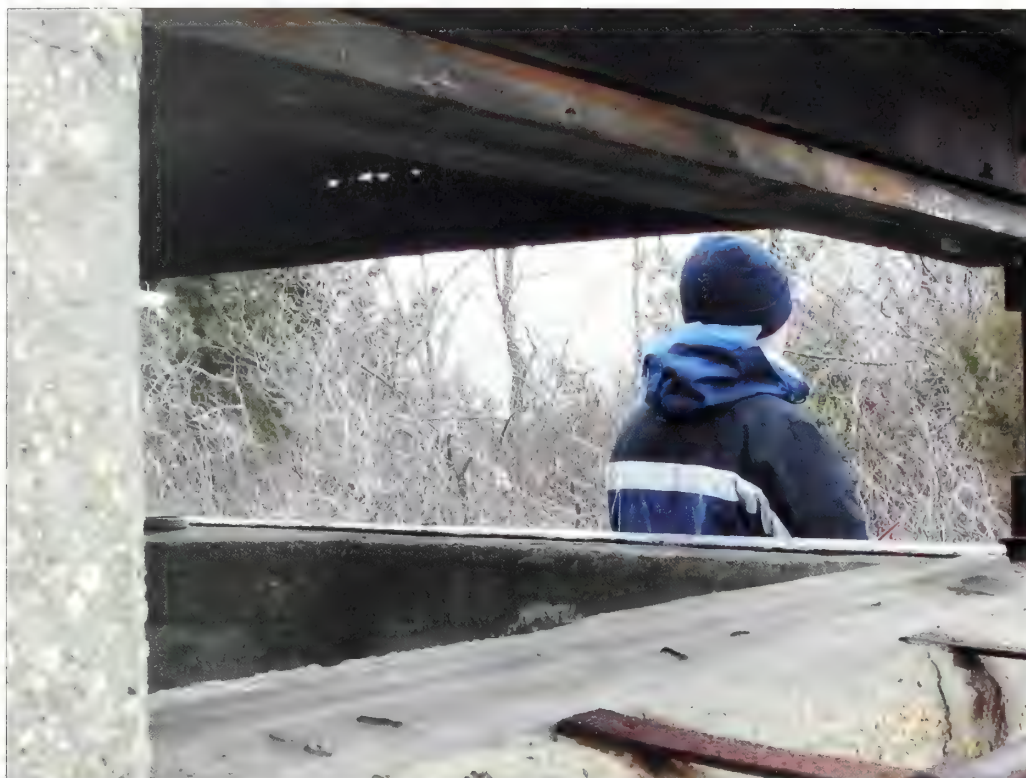
Batteries Engle and Peck survive in deteriorated condition. Downrange views from gun emplacements and range finder stations have been blocked by the growth of woody vegetation (Figures 5.36 and 5.37). Accumulation of windblown sand, organic matter and the growth of vines and other plants hinder access throughout the battery site. Concrete surfaces display widespread spalling, and metal fixtures such as handrails and door and window hardware are severely corroded.

Figure 5.37. Blocked downrange view looking northwest from the Battery Peck battery commander's station. Blocked views such as these may be readily reestablished by selectively removing out-of-scale woody vegetation. Views to the water from coastal batteries are critical in understanding the historic purpose and operation of the coastal defense system (Olmsted Center, January 2009).

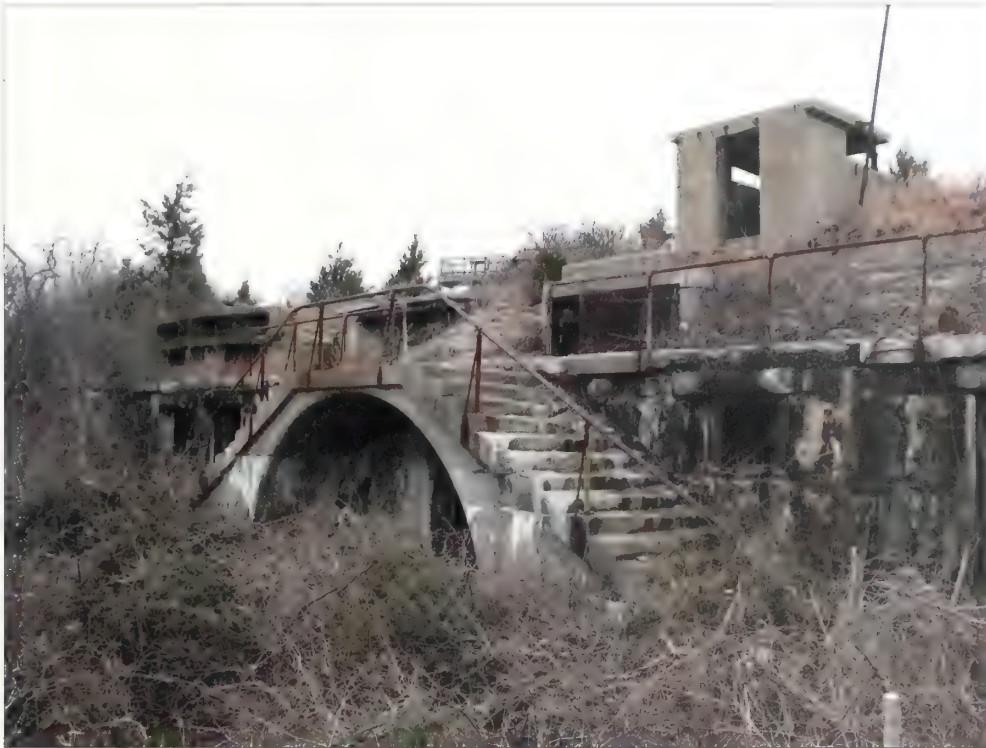
Today the area between the rear of Battery Peck and North Bragg Drive is filled with dense vegetation and is nearly impassable (Figure 5.39). In order to provide staff and visitor access, the vegetation growing between North Bragg Drive and the rear of Battery Peck should be removed. Removing the vegetation also rehabilitates the rear of Battery Peck to resemble the open character present during the battery's years of operation.

Figure 5.39. View looking northwest at Battery Peck. Today the area south of Battery Peck is filled with dense vegetation and is nearly impassable. Existing vegetation should be removed to resemble the open character present during the battery's years of operation and to improve access (Olmsted Center, January 2009).

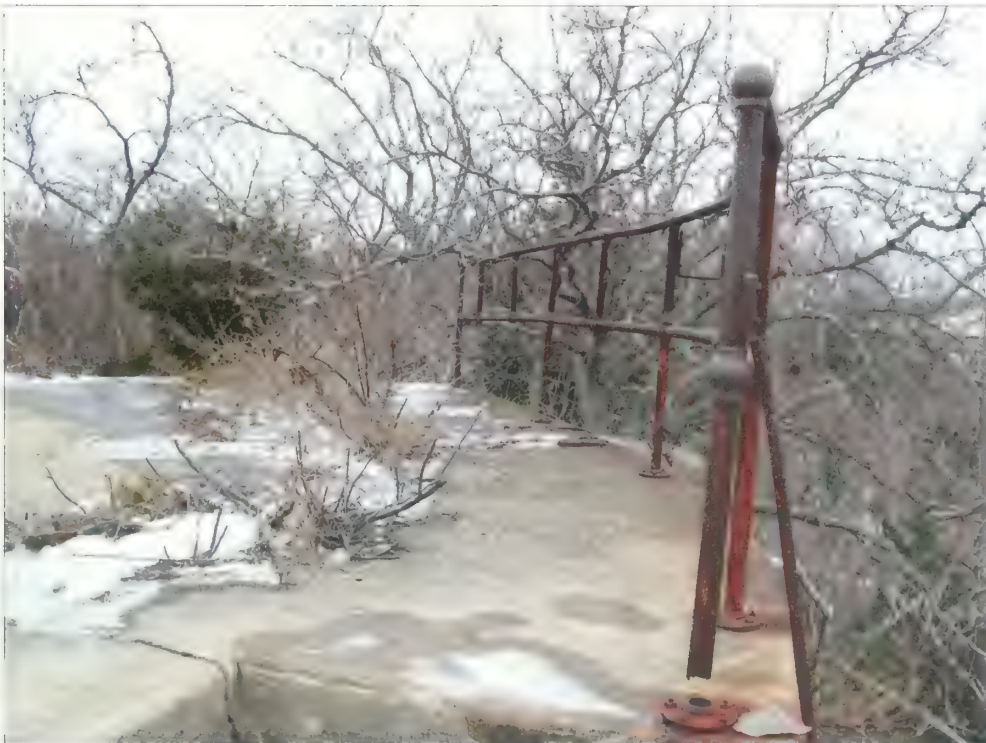
Figure 5.40. View of historic guardrail south of emplacement #1, Battery Peck. Severely deteriorated railing components, such as the vertical post in the foreground, should be removed and replaced with new components that match the original as close as possible. Final painting or a color-galvanized coating should match the historic railing paint finish (Olmsted Center, January 2009).

At batteries Engle and Peck, metal handrails line the steps that provided access from the ground level to the batteries. Metal guardrails are also installed near the open sides of elevated areas such as gun platforms (Figure 5.40). Metal railings in fair condition with visible rust should be chemically treated, primed, and painted to match the historic finish. Damaged or severely deteriorated railings should be

removed and replaced with new components that match the original as close as possible. Additional information on metal treatments and adding infill or applied materials to comply with life safety codes can be found in the treatment tasks common to all battery sites.

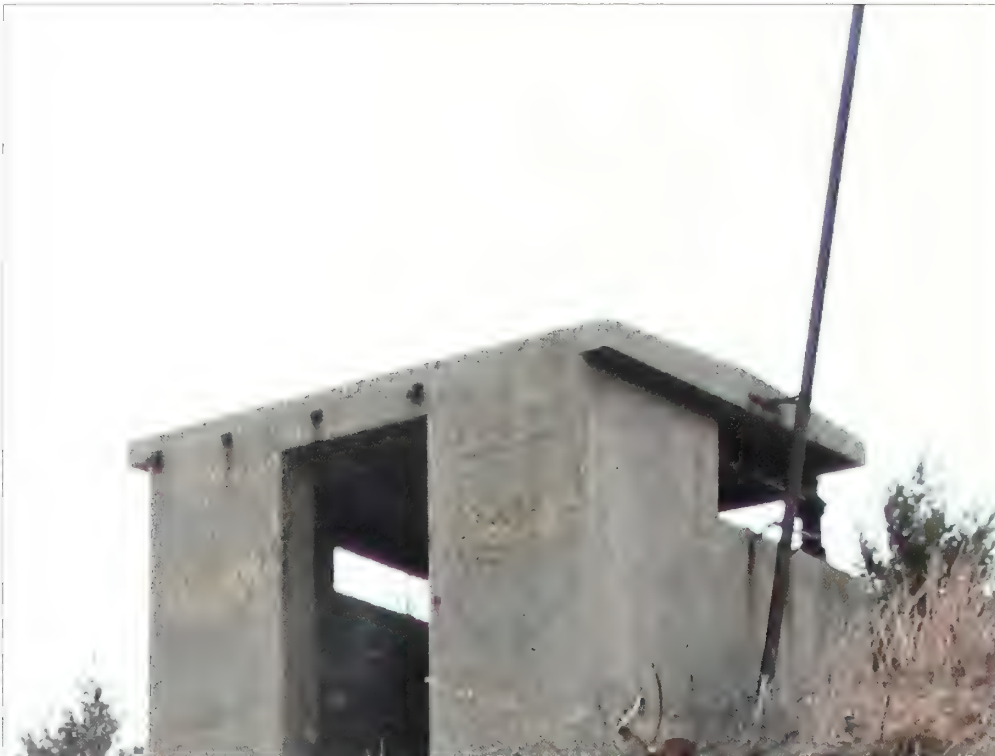
In addition to the repair work needed for the metal guardrails and handrails, Battery Peck has a metal antenna and mounting brackets that attached it to the commander's station (Figure 5.41).

Figure 5.41. View of northwest facade of Battery Peck's commander station. The metal antenna and mounting brackets are features of this structure and should be preserved or replaced in kind. Measured drawings should be prepared to document these features followed by corrosion treatment, priming, and painting to match the historic finish (Olmsted Center, January 2009).

This specific metal fixture is not present at the other batteries. A measured drawing of the antenna and brackets should be prepared to document these features. At a later date, these components may need to be replaced and fabricated based on the measured drawings.

The existing corrosion should be removed or made inert with a chemical treatment and immediately followed with priming and painting to match the historic finish.²⁷

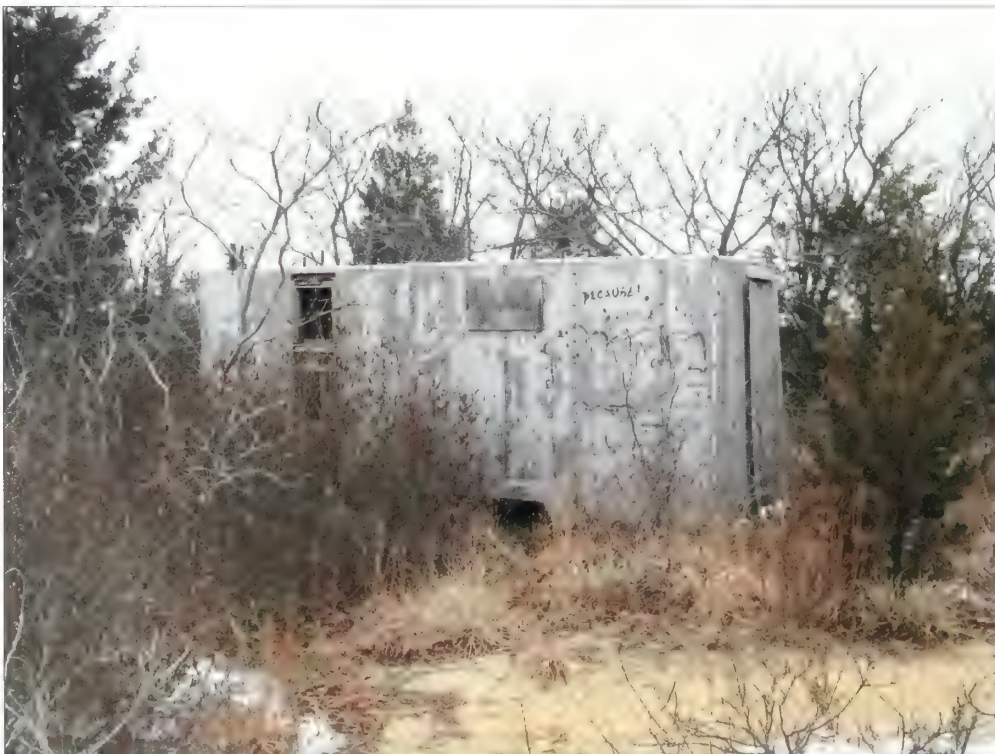
West of Battery Peck and in close proximity to the CRF station (Battery Engle), the Army set a communications trailer for the NIKE system (Figure 5.42). As recently as 1990, a map of Battery Peck indicated in addition to the trailer, a twelve-foot high chain-link fence topped with barbed wire surrounded much of the trailer and observation deck.

Figure 5.42. View looking north at a post World War II trailer located near Batteries Peck and Engle. The trailer is in a seriously deteriorated condition and, along with an accompanying section of fence, should be removed to improve the visual and spatial connection among Battery Peck's gun emplacements, commander station, CRF station, and the water in the distance (Olmsted Center, January 2009).

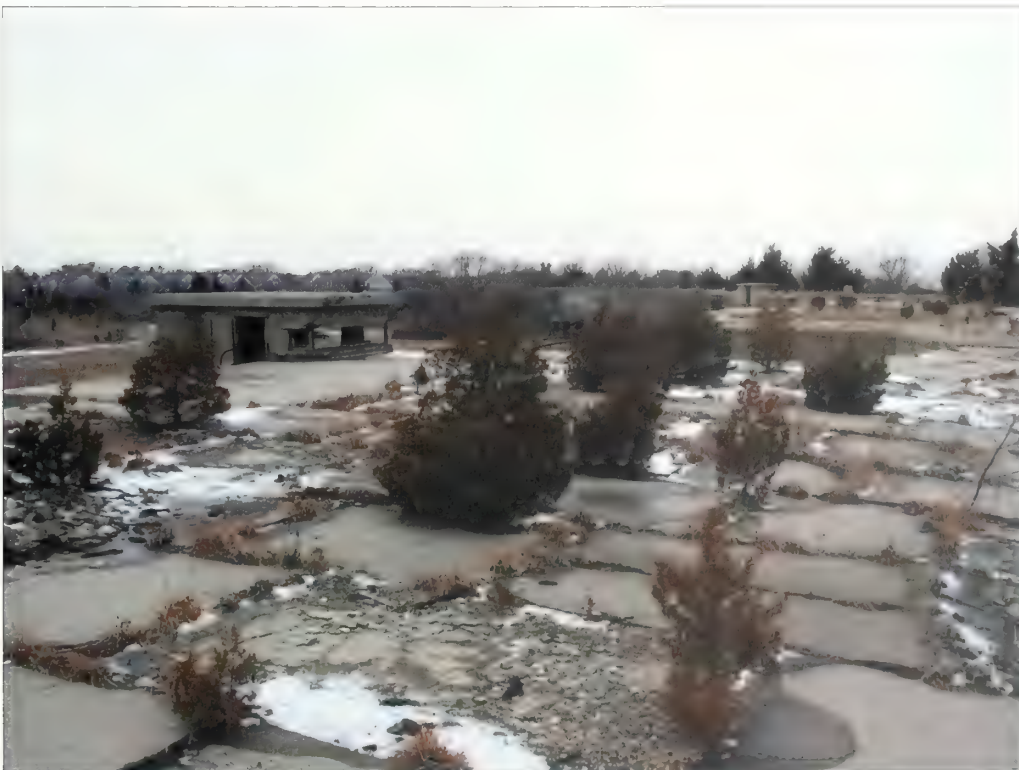
Figure 5.44. View looking west toward battery commander's station Bloomfield, Nine Gun Battery. Eastern red cedars (*Juniperus virginiana*) have become established in the joints of the concrete terreplein and should be removed (Olmsted Center, January 2009).

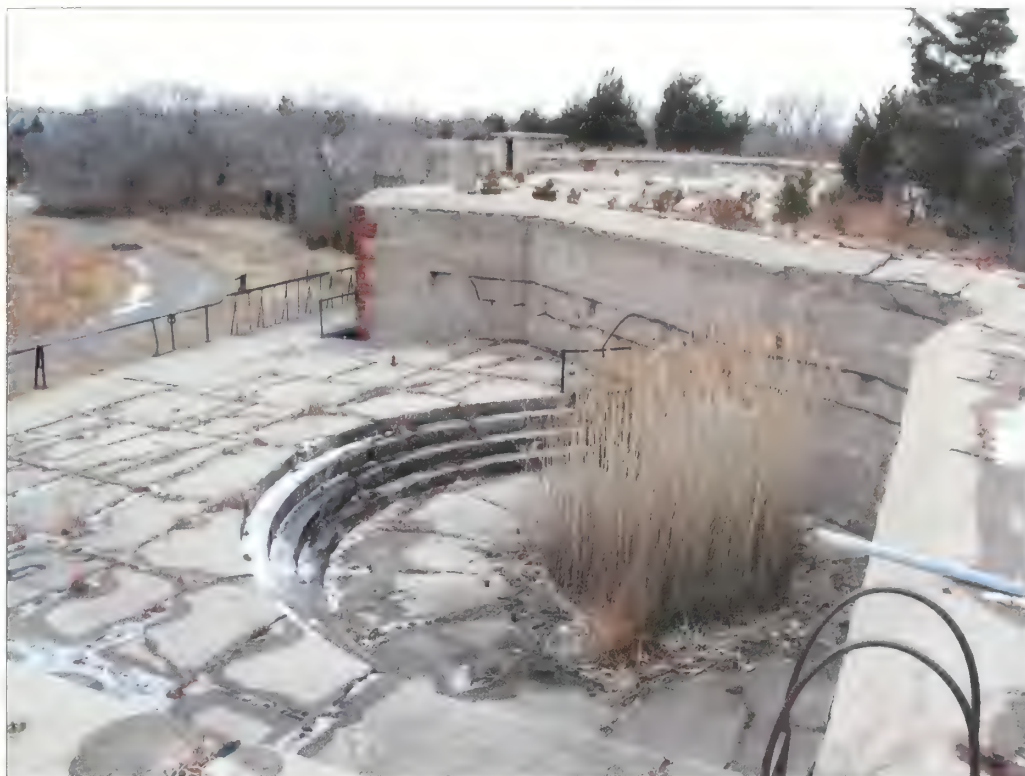
Figure 5.46. View of phragmites in gun well #6, Nine Gun Battery. Phragmites should be cut just after tasseling and the remaining stems should be treated with a hand-swiped application of a glyphosate herbicide (Olmsted Center, January 2009).

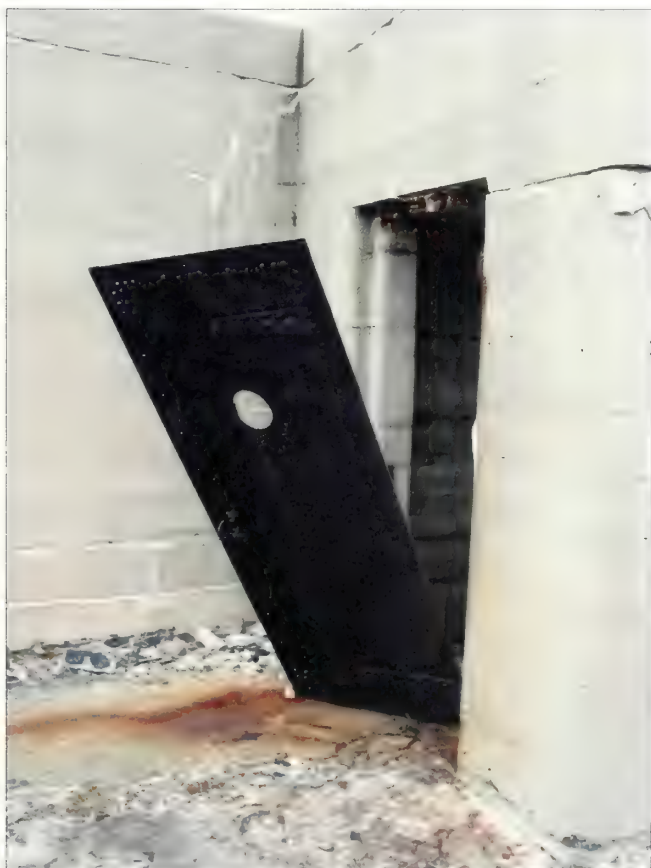
Figure 5.47. View of failing metal door, Nine Gun Battery. Doors and windows should be properly mounted and locked to prevent unauthorized access to interior spaces. While the door in view may be repaired, when a door is damaged or severely deteriorated, a new door should be fabricated to match the existing in materials and finish (Olmsted Center, January 2009).

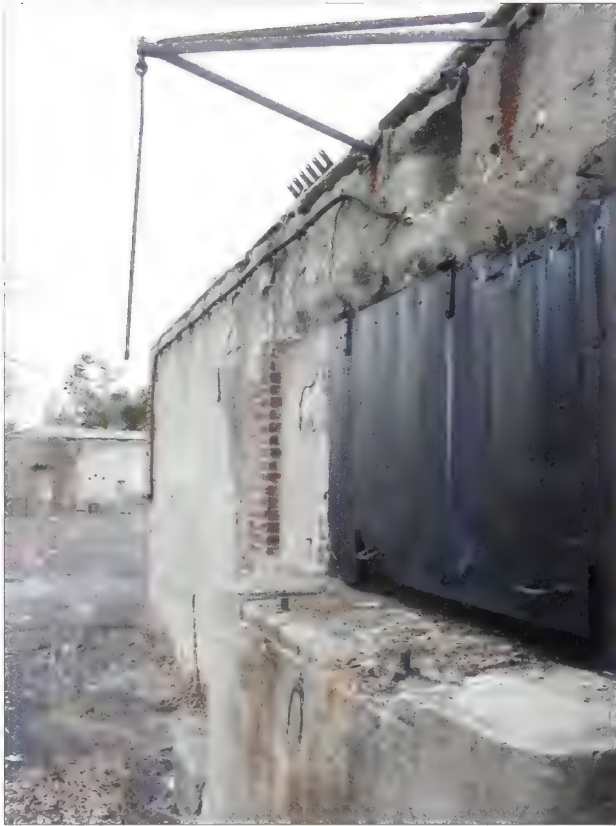
A variety of ferrous metal fixtures were incorporated into the construction of Nine Gun Battery (see Figure 5.48). Metal fixtures in fair condition with visible rust should be chemically treated, primed, and painted to match the historic finish. Damaged or severely deteriorated fixtures should be removed and replaced with new components that match the original as close as possible. Additional information on ferrous metal treatments can be found in the Safety Railings section of the treatment tasks common to all battery sites and in the *Historic Fortification Preservation Handbook* (Washington State Parks and Recreation Commission, 2003).

Figure 5.48. View of shell hoist metal door, Nine Gun Battery. Doors and windows should be properly mounted and locked to prevent unauthorized access. If a door is damaged or severely deteriorated, a new door should be fabricated to match the existing in materials and finish (Olmsted Center, January 2009).

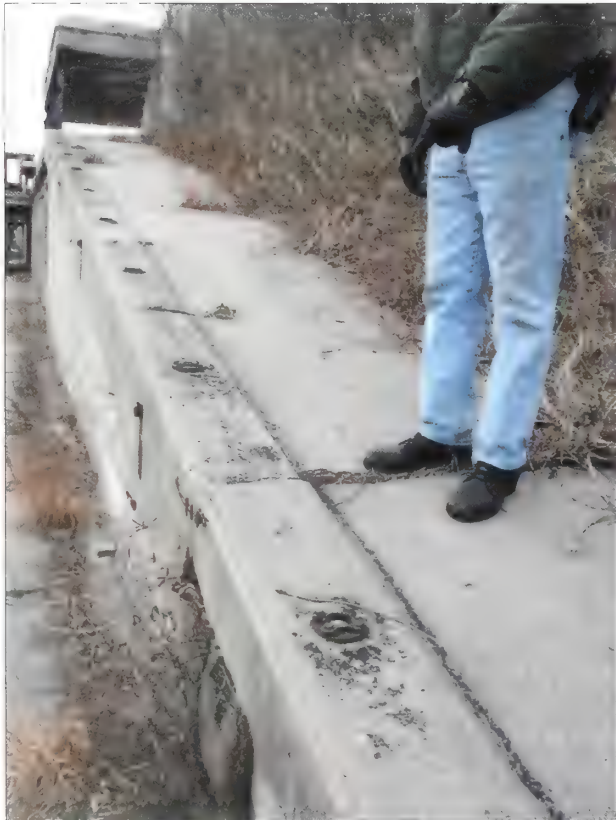
Figure 5.49. View looking northwest at the concrete ramp to gun platform #1, Nine Gun Battery. New safety railings should be installed on the ramp to facilitate visitor access. The rails should either attach to the existing escutcheon plates or be core drilled into the ramp's concrete structure. The new handrail components should match the original pipe railings and ball joint connectors at Nine Gun Battery to the greatest extent practicable (Olmsted Center, January 2009).

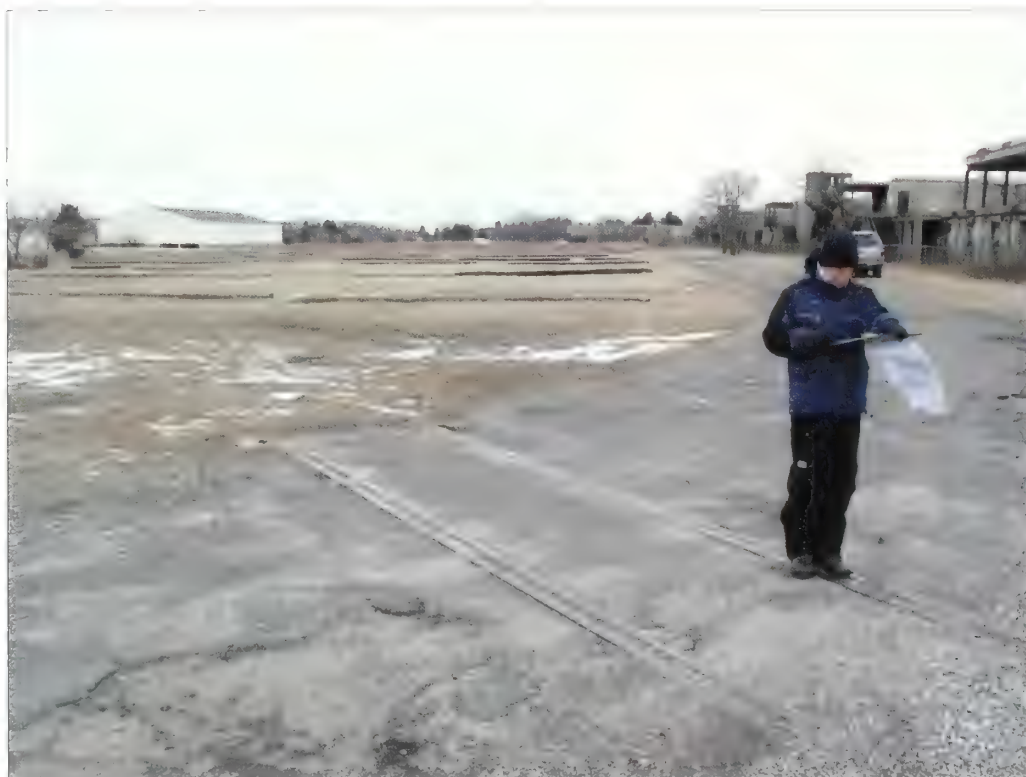
Although the railroad bed and ties are not visible, the tracks do appear in a section of asphalt pavement west of Nine Gun (Figure 5.53). From this location, the tracks should be extended roughly eighty-feet east to meet Lot J and west into the field for a sufficient length to locate a flatcar. The park no longer plans to use the field for overflow parking and as a result, there will be no conflict between parking requirements and adding this interpretive element. Extending the tracks to Lot J will help to physically draw visitors to the interpretive display and reveal a small part of a historic transportation system that is largely obscured.

Figure 5.53. View of extant railroad track, Nine Gun Battery. From this location, the tracks should be extended roughly eighty-feet east to meet parking lot J and west into the field for a sufficient length to locate a flatcar for interpretive purposes (Olmsted Center, January 2009).

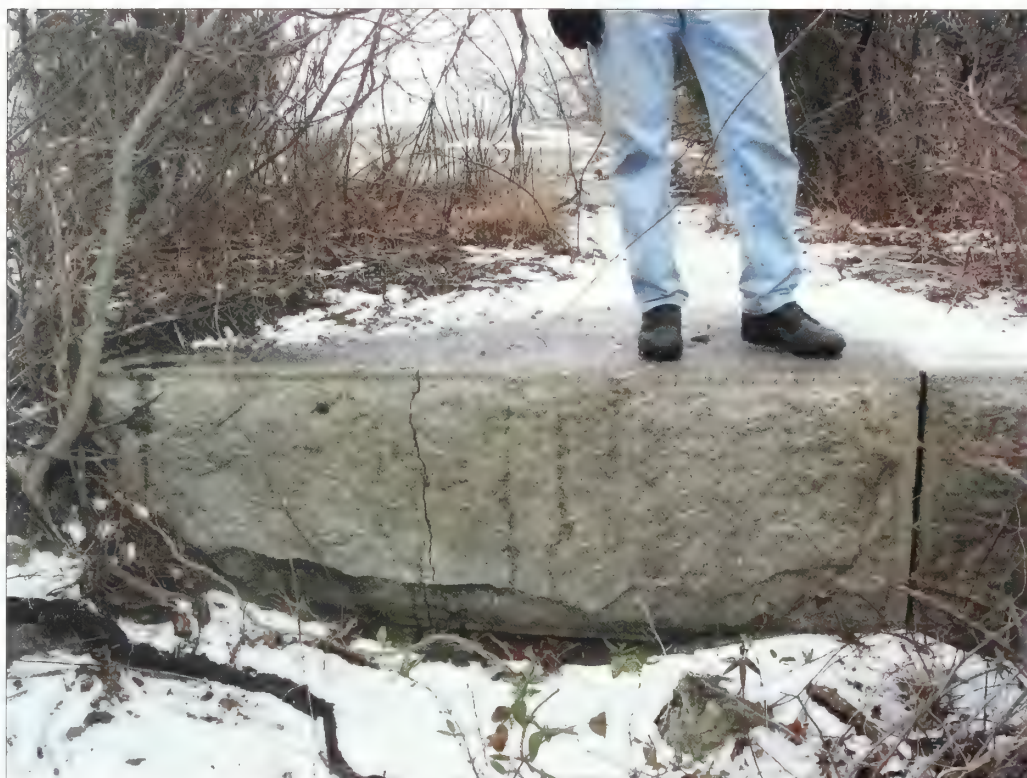
North of gun platform #8, evidence can be seen of granite blocks that comprised the northeast bastion of the Fort (Figure 5.56). In consultation with a regional archaeologist, an extant section of the bastion should be excavated and exposed. With a piece of the granite fort revealed, the proposed *Nine Gun Battery Visitor Access Plan* should incorporate interpretation of this prior structure as part of the continuum of Sandy Hook's coastal defenses.

Figure 5.56. Portion of the northeast curtain wall belonging to the former granite fort. This large granite block is located north of gun platform #8. A longer section of the curtain wall and northeast bastion could be carefully exposed to help park visitors understand and appreciate the multiple layers of coastal defenses at Sandy Hook (Olmsted Center, January 2009).

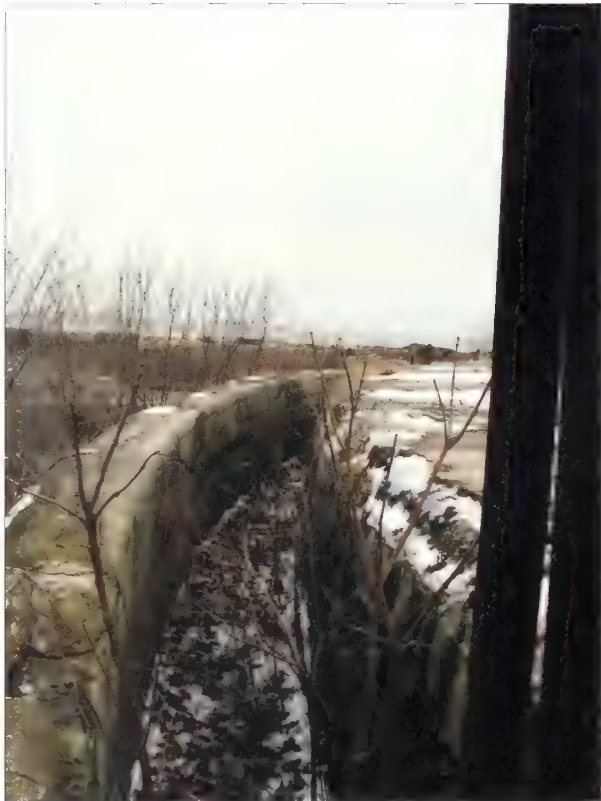
Figure 5.59. View looking east at the *chemin de ronde*, Battery Potter. Woody vegetation is growing in the *chemin de ronde*, a designed sentry route located north, south, and east of Battery Potter's superior slope. The vegetation threatens the historic battery's concrete features and surfaces and should be removed. After vegetation removals, the *chemin de ronde* should be regularly inspected and leaf litter and accumulated debris should be removed to prevent future vegetation growth and to protect the concrete surface (Olmsted Center, January 2009).

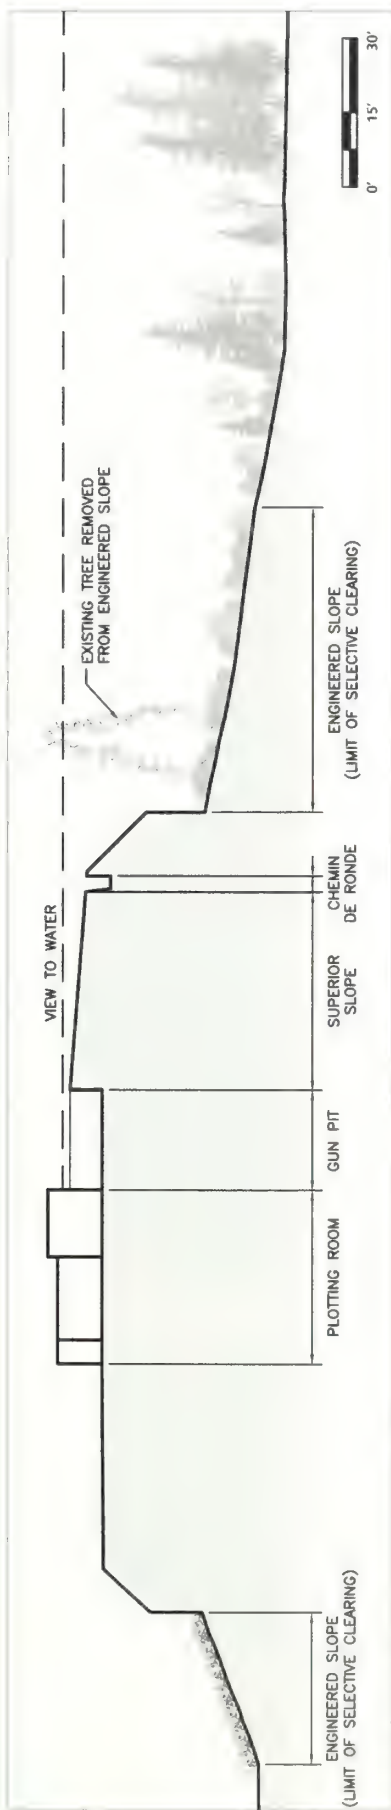
Figure 5.60. Conceptual section through Battery Potter. Existing, large woody vegetation on the engineered slope obstructs downrange views from the plotting rooms and terreplein to the water. Large woody vegetation on the engineered slope should be removed to restore views and protect the historic earthwork from potential damage due to thrown trees. Existing vegetation beyond the toe of the engineered slope may not impact views due to the viewing height on Battery Potter (Olmsted Center, 2009).

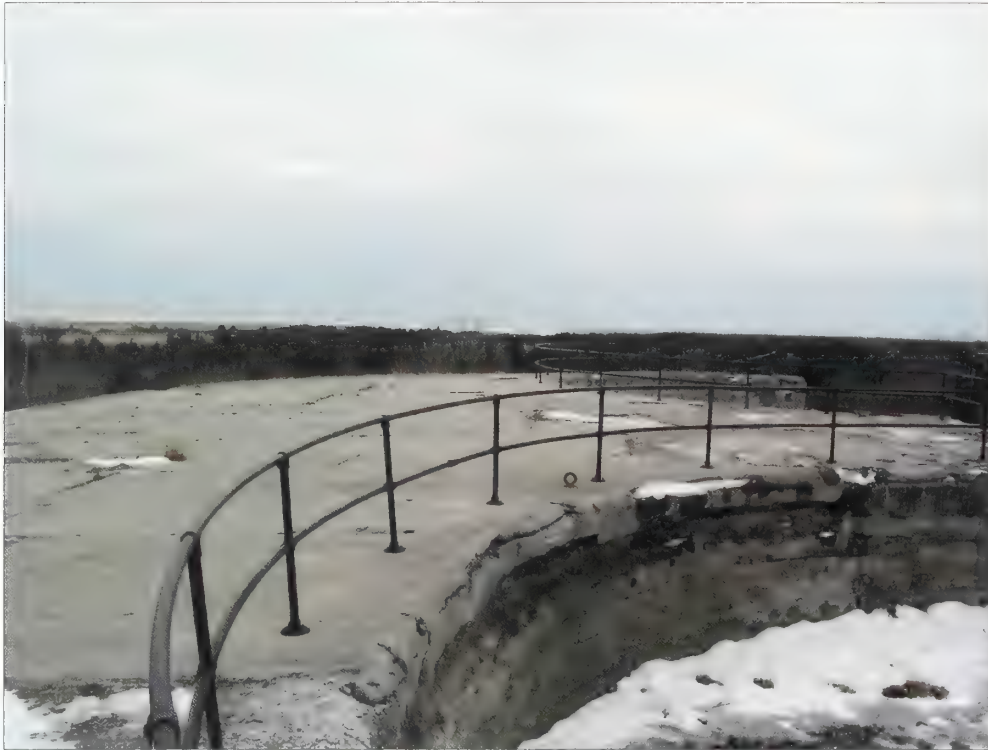
Figure 5.61. Recently installed contemporary safety railing, Battery Potter. Woven-wire may be either installed as infill panel, or the mesh applied with clamps to satisfy life-safety codes (Olmsted Center, January 2009).

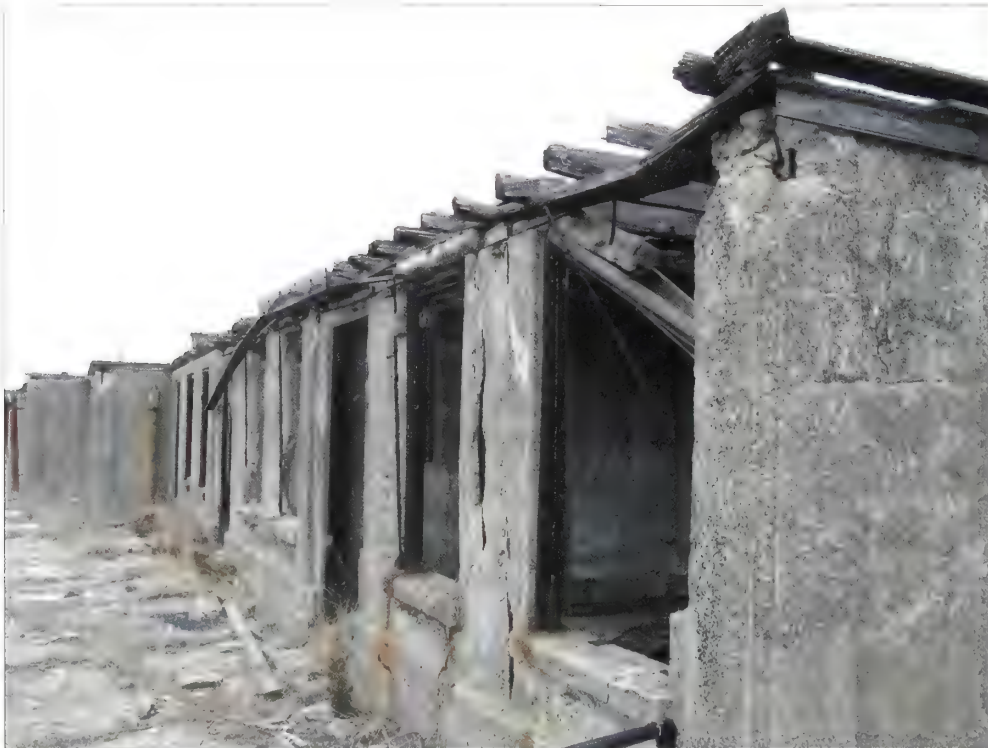
Figure 5.62. Plotting rooms, Battery Potter. In improving physical access to the upper level of Battery Potter for use as an elevated prospect, rehabilitating the deteriorated plotting rooms shown here may be of some value for interpretive purposes. Once the roofs of these buildings are replaced, the interiors may be used to house durable exhibitry. Enamelled interpretive wayside panels may effectively substitute for missing window frames, offering detailed graphic interpretation of Battery Potter and the entire coastal defense system (Olmsted Center, January 2009).

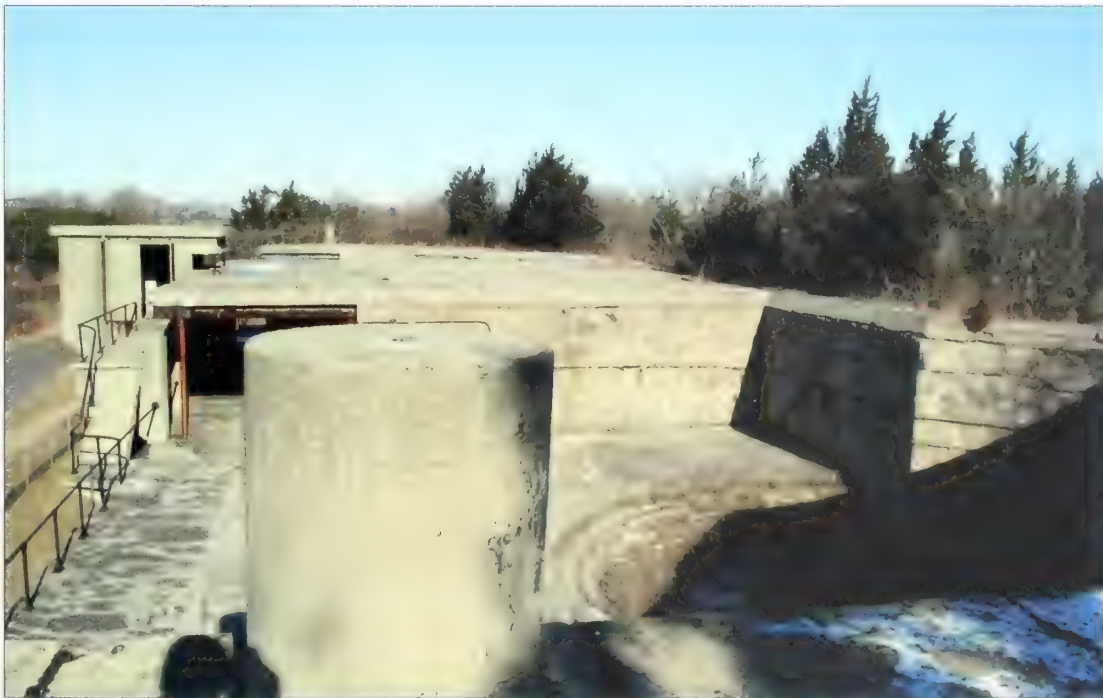
Battery Granger stands east of Hudson Drive and is presently not open to visitors. The park has installed a chain-link fence and signage between the road and battery to warn visitors of potentially hazardous conditions (Figure 5.64). Efflorescence can be seen on some vertical concrete surfaces and small spalling areas are present on both horizontal and vertical surfaces. The views from the commander's station to the water are blocked by woody vegetation first encountered at the edge of the terreplein and continuing on the engineered earthwork. Phragmites, also called common reed, is growing in the wells at both gun platforms. Guardrails are located along the terreplein on either side of the commander's station. The railings are in good to fair condition showing limited corrosion, however, they contain large openings that do not provide safety for all visitors.

Figure 5.64. View looking north at emplacement #1 and battery commander's station, Battery Granger. Battery Granger is accessed via Hudson Drive, left, and a chain-link fence and signage have been installed between the road and battery to warn visitors of potentially hazardous conditions. Eastern red cedars, right, are heavily concentrated at the interface of the engineered slope and the battery's concrete terreplein (Olmsted Center, January 2009).

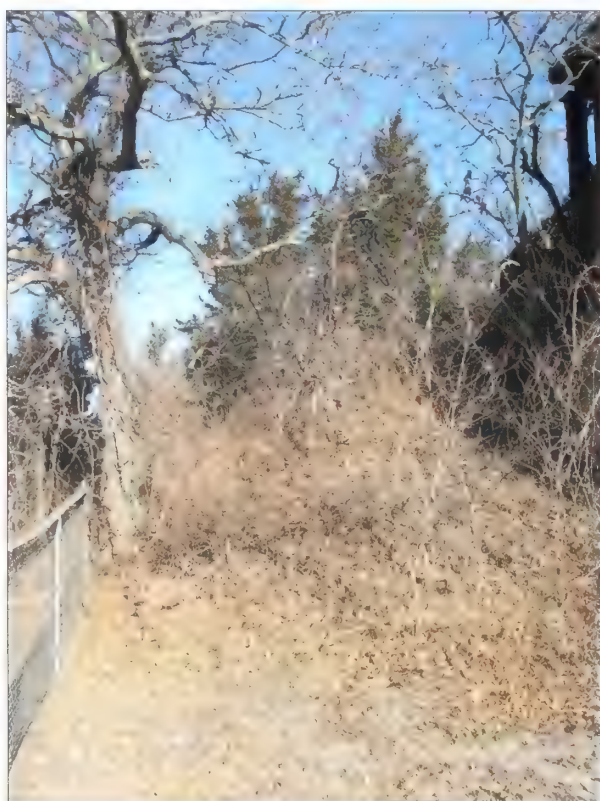
Figure 5.66. View looking northwest at engineered slope to rear of Battery Granger, host to large unmanaged woody vegetation (Olmsted Center, January 2009).

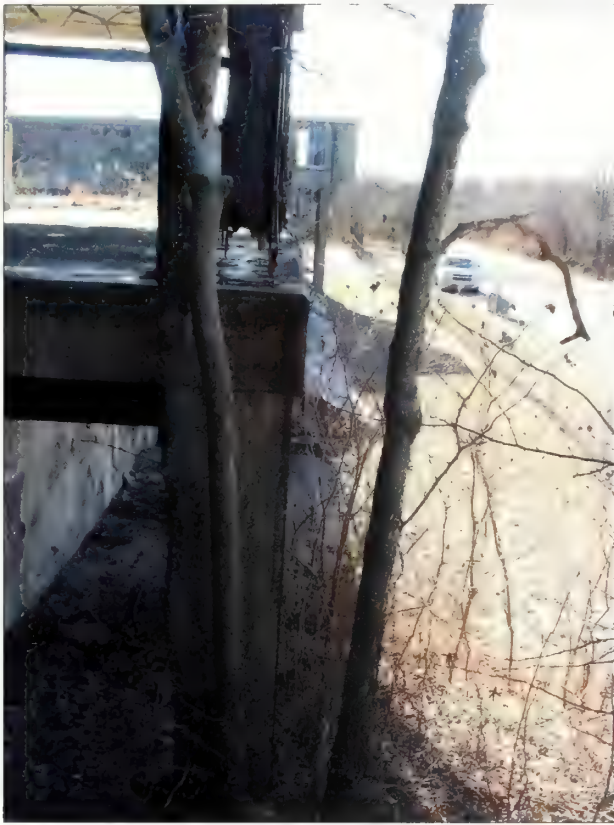
At Battery Granger, woody vegetation is growing in close proximity to concrete structures and is also emerging from spalling areas, cracks, and where leaf litter and debris have accumulated (Figure 5.67). The existing woody vegetation is either causing or has the potential to cause structural concrete problems. Given the harmful effect of woody vegetation in this situation, all woody vegetation growing on or within four-feet of concrete features should be removed. After removing the woody material, both deciduous and evergreen stumps should be treated with a triclopyr herbicide. Additional information on removing woody vegetation growing near and on structures can be found in the treatment tasks common to all battery sites.

Figure 5.67. View looking southeast at Battery Granger. This image shows three large hackberry (*Celtis occidentalis*) trees growing directly adjacent to the corner of the concrete structure (Olmsted Center, January 2009).

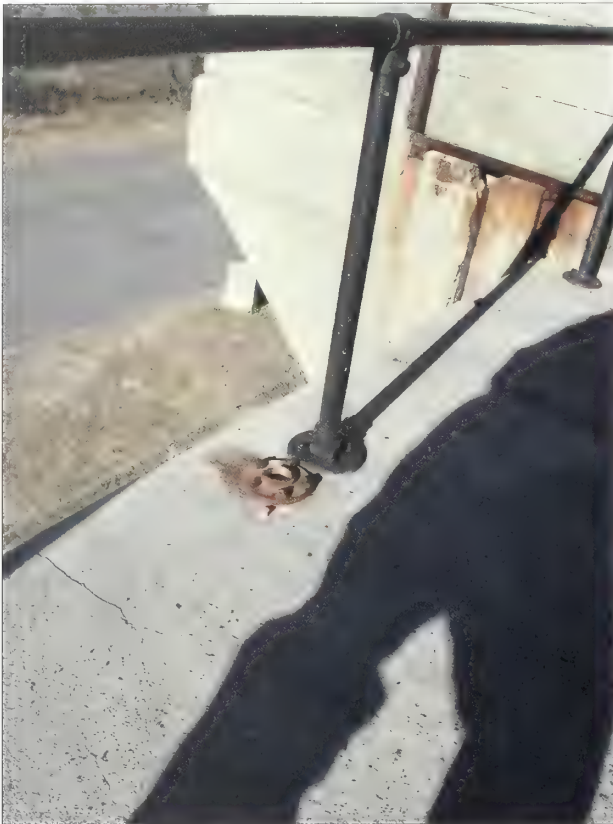
Figure 5.69. Existing safety railings, Battery Granger. At this location and elsewhere throughout Sandy Hook's coastal defense sites, one can see the tangible history of maintenance and repair. This simple railing may be retrofitted with either infill mesh panels or otherwise with woven wire mesh applied with clamps and hardware to satisfy life-safety codes (Olmsted Center, January 2009).

At Battery Granger, metal guardrails are installed near the open sides of the gun platforms (Figure 5.69). Metal railings in fair condition with visible rust should be chemically treated, primed, and painted to match the historic finish. Damaged or severely deteriorated railings should be removed and replaced with new components that match the original as close as possible. Additional information on metal treatments and adding infill or applied materials to comply with life safety codes can be found in the treatment tasks common to all battery sites.

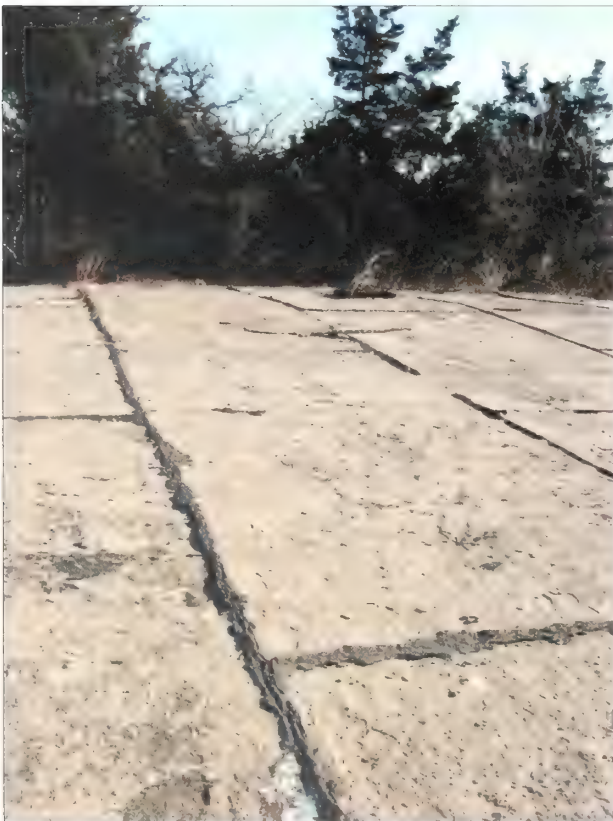
Figure 5.70. Close-up view of existing concrete terreplein, Battery Granger. Existing conditions indicate that joints between concrete panels were once sealed with bituminous material. With the passage of time, this sealant material requires maintenance (Olmsted Center, January 2009).

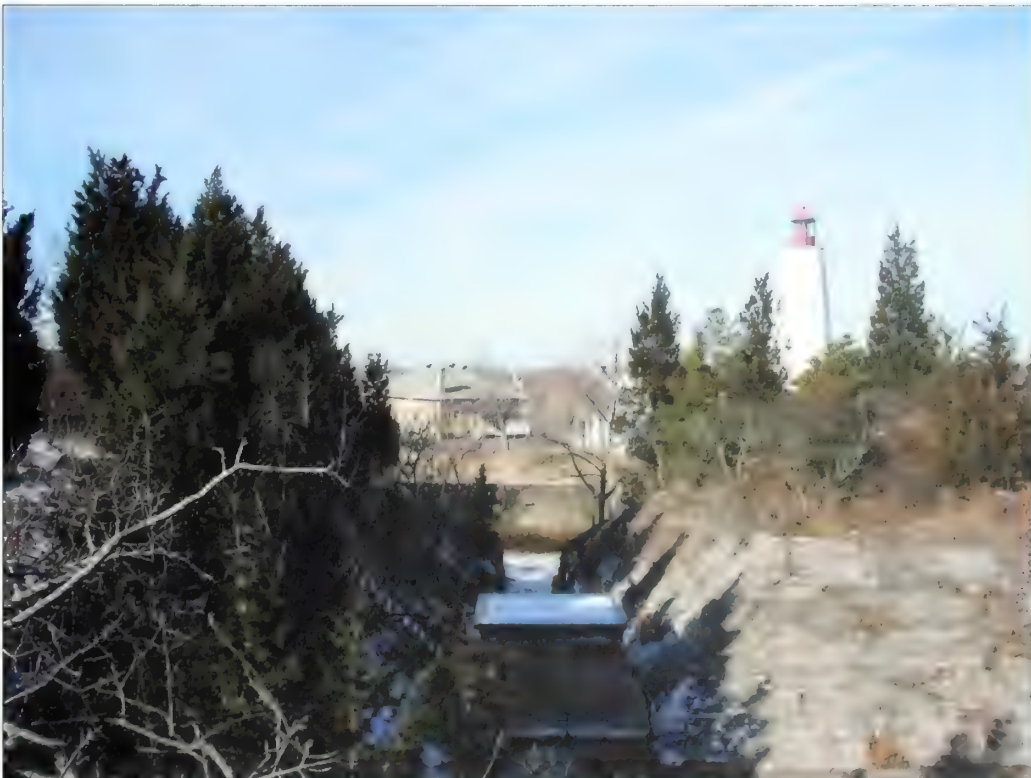
A mixture of vegetation presently grows on the engineered earthwork at the Mortar Battery including native and non-native vines and groundcovers, grasses, shrubs, and large woody vegetation (Figures 5.72 and 5.73). Large woody vegetation defines any deciduous or evergreen tree that has a trunk size greater than four-inches diameter at breast height. Given this size, a tree that topples over due to wind, rain, snow, or ice is likely to damage a portion of the engineered earthwork. Additionally, the tree roots can damage the concrete structures below the protective earthwork. In order to protect the historic

Figure 5.72. View looking northwest above mortar pit, the Mortar Battery. Woody vegetation greater than four-inches diameter should be removed from engineered slopes, and all woody trees and shrubs must not be allowed to grow upon, or within four-feet of a concrete structure or feature (Olmsted Center, January 2009).

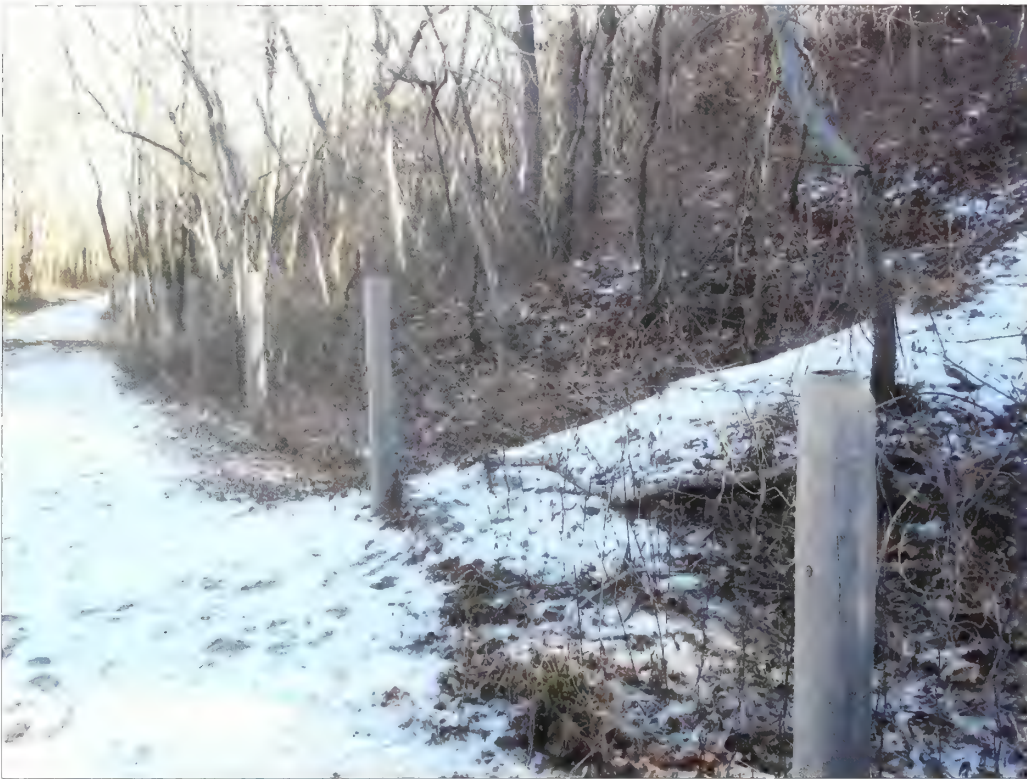
Figure 5.73. View looking northeast along interior trail, the Mortar Battery. In order to protect the historic earthwork, woody vegetation greater than four-inches diameter at breast height should be selectively removed (Olmsted Center, January 2009).

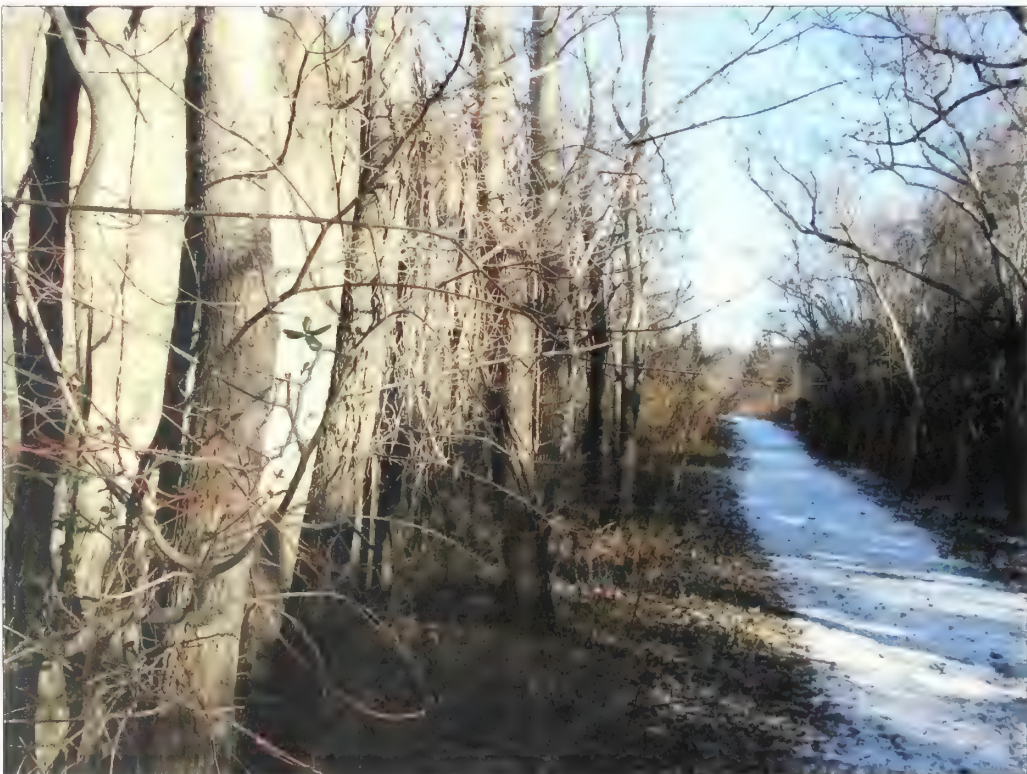
At the Mortar Battery, woody vegetation is growing in close proximity to concrete structures and is also emerging from spalling areas, cracks, and where leaf litter and debris have accumulated (Figures 5.74 and 5.75). The existing woody vegetation is either causing or has the potential to cause structural concrete problems. Given the harmful effect of woody vegetation in this situation, all woody vegetation growing on or within four-feet of concrete features should be removed. After removing the woody material, both deciduous and evergreen stumps should be treated with a triclopyr herbicide. Additional information on removing woody vegetation growing near and on structures can be found in the treatment tasks common to all battery sites.

Figure 5.74. View looking northwest along interior trail, the Mortar Battery. Given the harmful effect of woody vegetation growing in close proximity to concrete structures, all woody vegetation growing on or within four feet of concrete features should be removed (Olmsted Center, January 2009).
